SITE ASSESSMENT REPORT
FOR
THE DAYTON ELECTROPLATE, INC., SITE
DAYTON, MONTGOMERY COUNTY, OHIO
TDD: S05-9609-018
PAN: 6P1801SI
DOCUMENT CONTROL NUMBER: START-05-23-05019

December 19, 1996

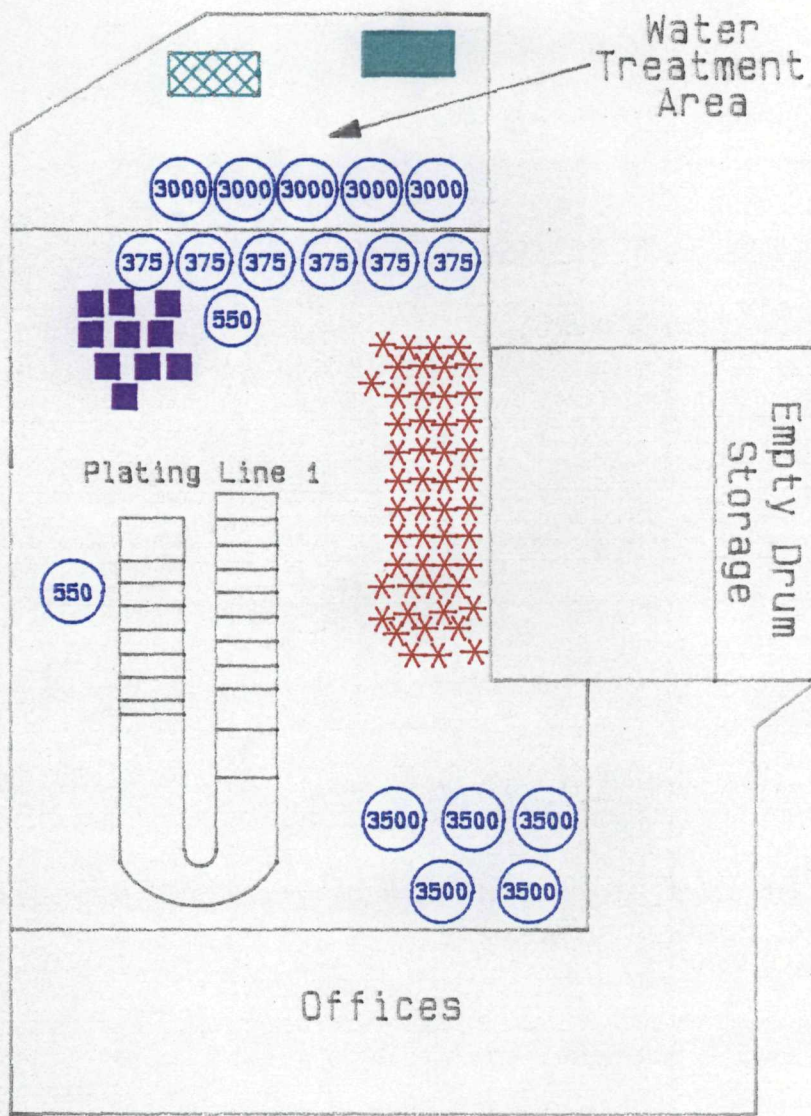
TITLE	Building 1 Detail Map	FIGURE	3-1
SITE	Dayton Electroplate, Inc.	SCALE	Not To Scale
CITY	Dayton	STATE	Ohio
SOURCE	Ecology and Environment Inc.	PAN	6P1801SI
		DATE	1996
		REVISED

Building 1: Building 1 is located near the center of the site property and is contained within the same structure as Building 3 (refer to Figure 3-1 for Building 1 Detail Map). It consists of a number of rooms, and appears to have contained the offices and support areas associated with the business during its operation.

Entry to Building 1 was obtained through a walk-in door along the west side of the building. This area consisted of several smaller rooms adjacent to a central hallway. One of these rooms was utilized for storage of empty drums. Approximately 21 empty 55-gallon drums, seven empty 30-gallon drums, and one empty 20-gallon drum were observed in this area. Empty drums in this storage area were stacked two high in some locations.

Five large closed, fiberglass-wrapped tanks were observed in the northwest corner of the main room in Building 1. Contents of the storage tanks are unknown, although the tanks are assumed to be full. Access to the tops of each of the storage tanks requires a ladder, which was unavailable at the time of the site assessment. Each tank has an estimated capacity of 3,500 gallons. One of the tanks was labelled as "Alkali Holding." Standing liquids, possibly rain water or leakage from plating vats or the storage tanks themselves, was observed around the base of these storage tanks and around the north end of Plating Line 1. A reading of approximately 280 ppm above background levels was obtained on the PID during the site reconnaissance of this area. An additional 550-gallon capacity closed,

fiberglass-wrapped storage tank was observed at the southeast corner of Plating Line 1. It is assumed that this tank is also full.

Seven additional smaller storage tanks, with capacities ranging from 375 to 550 gallons, were observed at the south end of the main room in Building 1. These tanks appeared to be constructed of polyethylene (poly) plastic and were open to the atmosphere. Each tank contained a power-operated mixer, and tanks appeared to be connected via piping. One of these seven storage tanks was observed to be approximately 75% full, and the remaining six tanks were observed to be approximately 25% full, of unknown liquids.

A separate room, located at the south end of Building 1, appeared to have been utilized as a water treatment area for wastewater pretreatment prior to sewer discharge. This room contained an additional five large, open-top, fiberglass-wrapped storage tanks. Each of these tanks had an estimated capacity of 3,000 gallons, and were observed to be approximately 80% full. In addition, a 20-cubic-yard roll-off box, which appeared to be full of dried electroplating sludges, was observed in the southwest corner of the water treatment area. A large vat was also located in the southeast corner of this room. The 2,150-gallon capacity vat was nearly full of an unknown liquid.

Approximately 70 full 55-gallon drums were observed in Building 1 along the west wall of the main room. Drums of unused products, stacked two drums high, were stored on pallets along the wall. The drums were staged by chemical name, based on small signs located on the wall. However, drums of acids, such as nitric (2 drums), sulfuric (8 drums), and hydrochloric (20 drums), were observed stored adjacent to drums of basic materials, such as sodium hydroxide (16 drums) and sodium hypochlorite (12 drums). A list of drums and containers inventoried by START during the site assessment, separated by building and area, is included as Appendix B.

An additional ten full 55-gallon drums of sulfuric acid (4), sodium hydroxide (4), and sodium hypochlorite (2) were observed at the southeast corner of the main room, adjacent to the water treatment area. The concrete floor in the vicinity of these drums was observed to be stained yellow in several locations. Labels from other containers observed in Building 1 indicated the presence of the following products: "Zincrolyte," "Enthobrite," and "SoakClean," as well as several unknown materials.

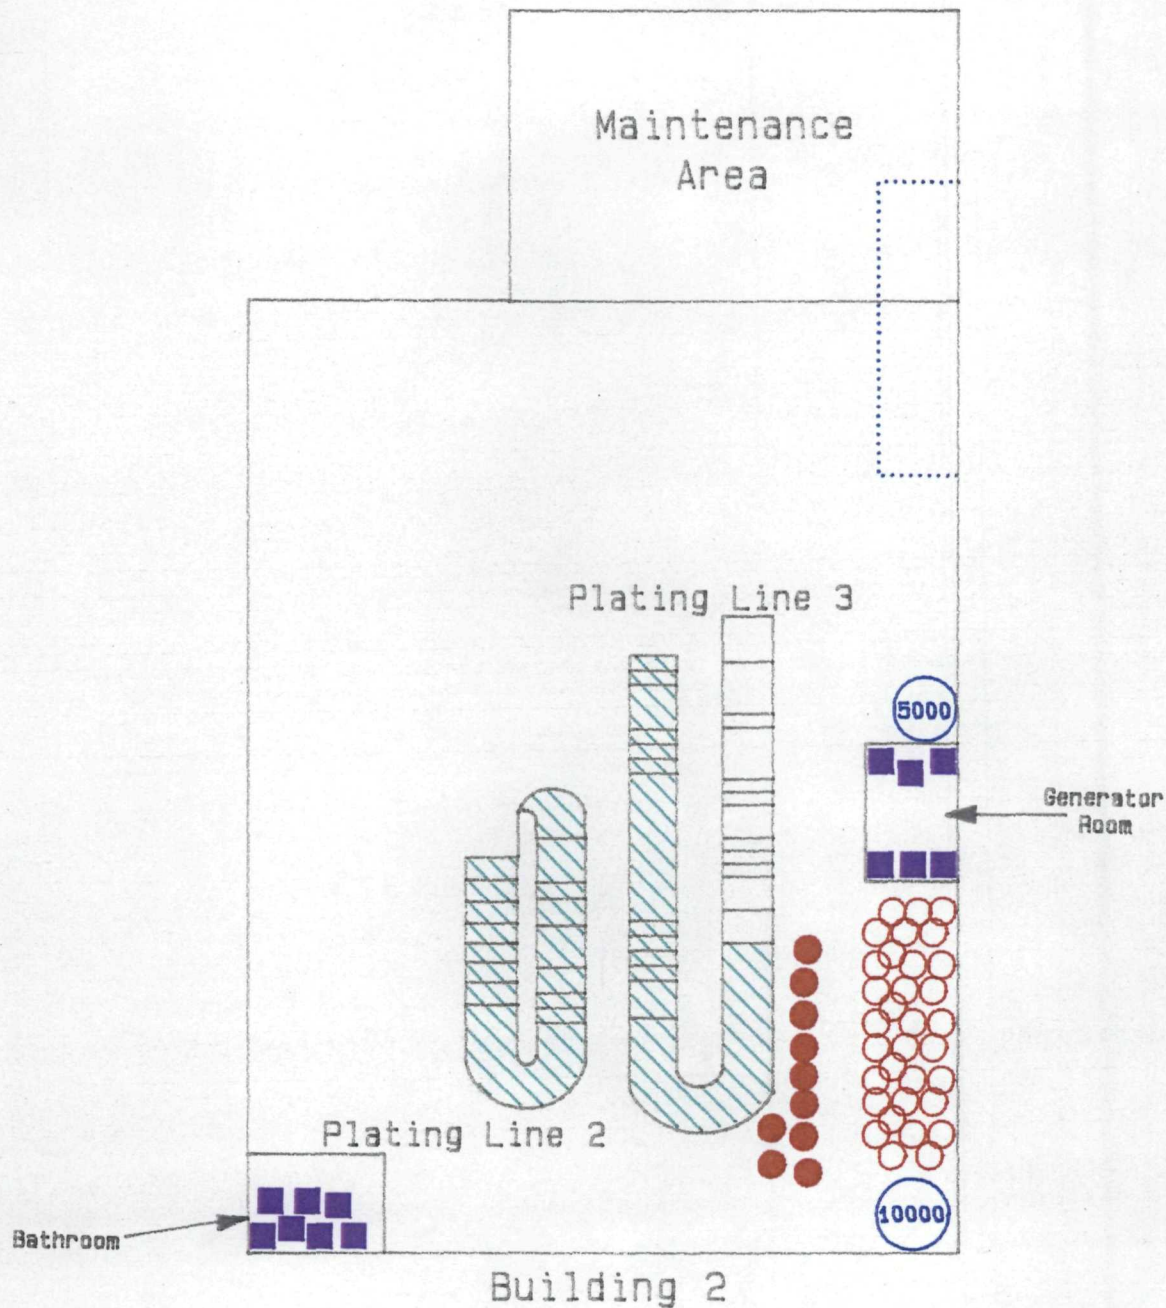
TITLE	Building 2 Detail Map	FIGURE	3-3
SITE	Dayton Electroplate, Inc.	SCALE	Not To Scale
CITY	Dayton	STATE	Ohio
SOURCE	Ecology and Environment Inc.	PAN	6P1801SI
		DATE	1996
		REVISED

Building 2: Building 2 contains Plating Lines 2 and 3 (refer to Figure 3-3 for Building 2 Detail Map). Plating Line 2 consists of 16 separate vats, ranging in size from approximately 1,000 to 5,000 gallons in capacity. All of the vats in Plating Line 2 were empty at the time of the site assessment.

Plating Line 3 contains 25 separate vats, ranging in capacity from 1,000 to 10,000 gallons. Approximately half of the vats in this plating line were empty at the time of the site assessment. The remaining vats were approximately 75% full of liquids and sludges. The large, horseshoe-shaped plating vat was empty of electroplating materials at the time of the site assessment, but contained several large portable kerosene heaters. Ten full 55-gallon drums labelled as containing kerosene were observed adjacent to the west side of this vat.

A large steel storage tank was observed in the northwest corner of Building 2. The tank has an estimated capacity of 10,000 gallons, but was observed to be empty at the time of the site assessment. A second storage tank, with an estimated capacity of 5,000 gallons, was observed along the west side of Building 2. The contents of this tank are unknown, although it is assumed to be half full.

A generator room is located along the west wall of Building 2, between the two storage tanks. One 30-gallon and two 20-gallon drums of sodium cyanide and one 30-gallon and two 20-gallon drums of zinc cyanide were observed in this room.

A group of 33 55-gallon drums were observed along the west wall of Building 2, between the generator room and the 10,000-gallon storage tank. The drums were labelled with "Amphoteric 2150RR." Additional label information indicated these materials were cleaning compounds which contained hydrofluoric acid. The contents of one of these drums was field-tested with pH paper and indicated a pH of 1 S.U. Drums in this area were stored on the floor and on an overhead storage area against the wall. A complete inventory of this area was not possible due to the lack of a ladder required to access the overhead storage shelf. These drums are located within 10 to 15 feet of the drums of sodium and zinc cyanides.

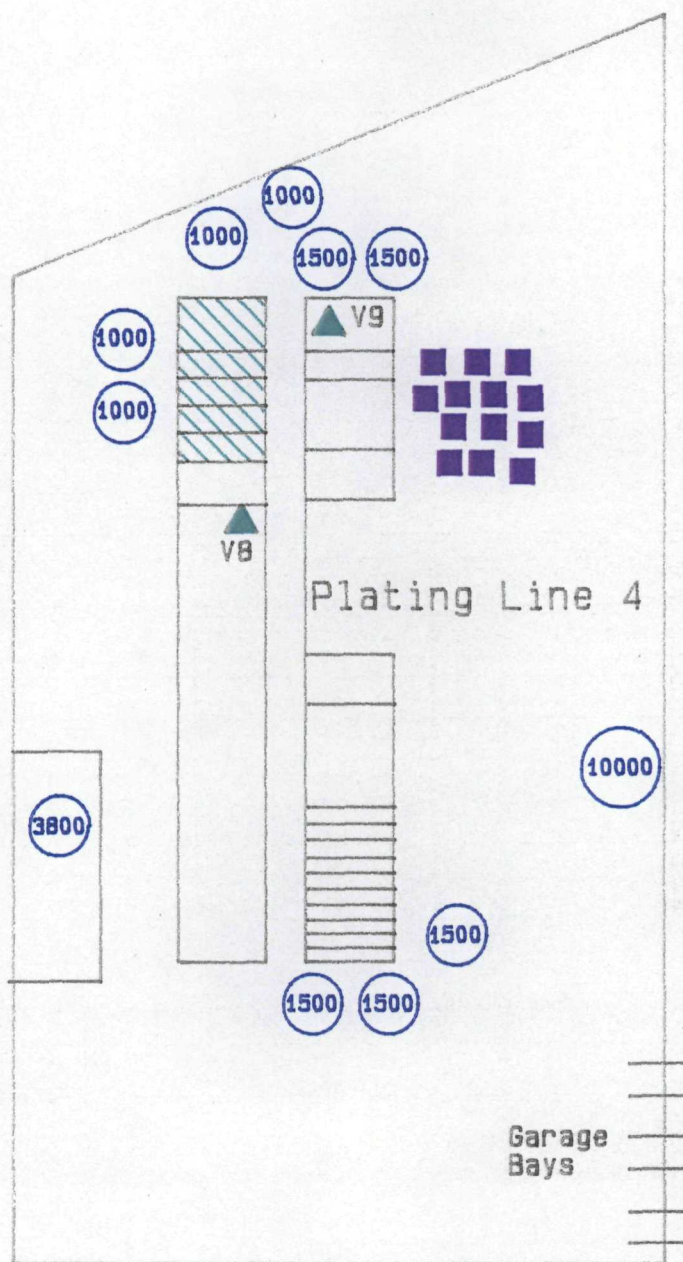
TITLE	Building 3 Sample Location Map	FIGURE	3-5
SITE	Dayton Electroplate, Inc.	SCALE	Not To Scale
CITY	Dayton	STATE	Ohio
SOURCE	Ecology and Environment Inc.	PAN	6P1801SI
		DATE	1996
		REVISED

Vat samples V8 and V9 were collected from plating vats from Plating Line 4 in Building 3 (refer to Figure 3-5 for Building 3 Sample Locations). Sample V8 was a clear, light yellow liquid which tested positive for cyanide content when field-tested with an EM Quant cyanide test kit. Vat sample V9 was a clear, light green liquid which indicated a pH of 1 S.U. when tested with pH paper.

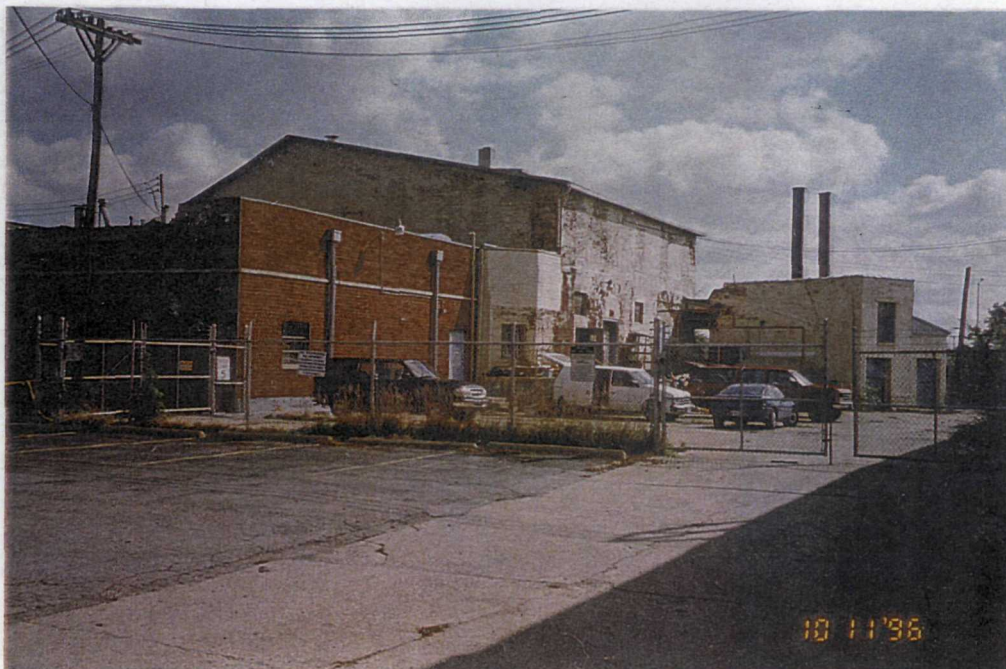
SITE: Dayton Electro.TDD: S05-9609-018 PAN: 6P1801SA PHOTO: 4
 DIRECTION: Southeast DATE: 10/11/96 PHOTOGRAPHER: Renninger
 DESCRIPTION: Exterior of Building 1.

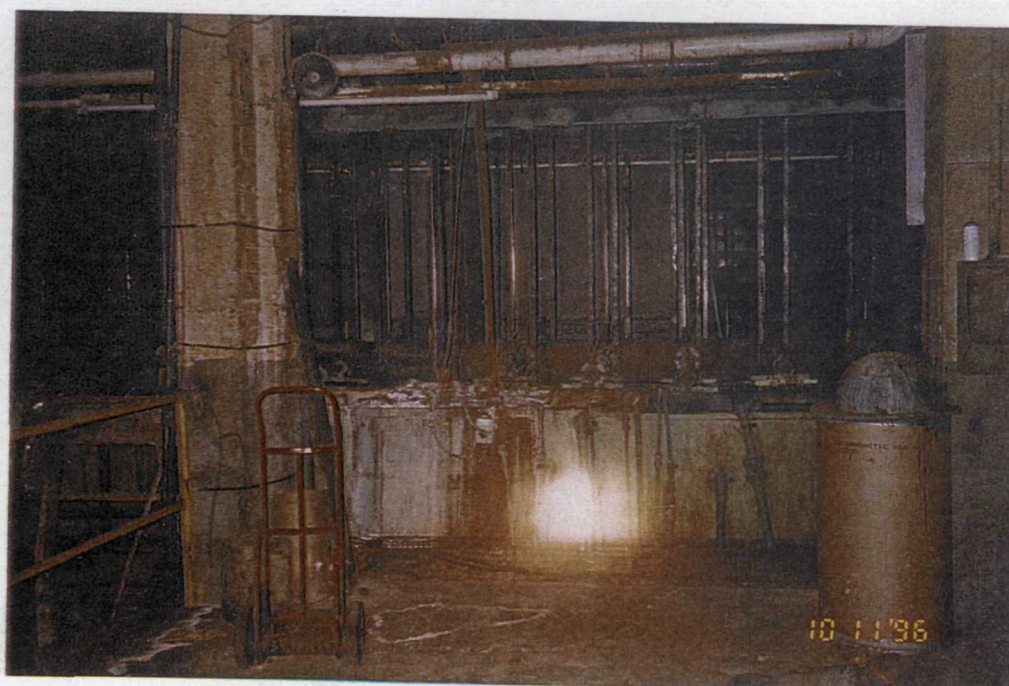
SITE: Dayton Electro.TDD: S05-9609-018 PAN: 6P1801SA PHOTO: 12
 DIRECTION: East DATE: 10/11/96 PHOTOGRAPHER: Renninger
 DESCRIPTION: Overview of the west side of the plating line in Building 1.

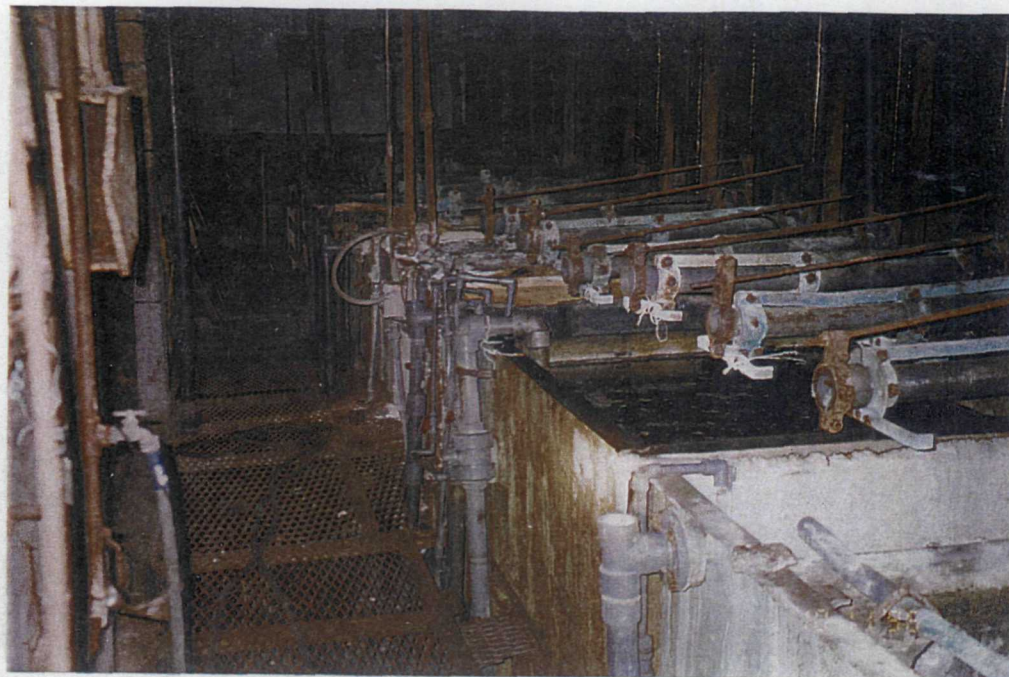
SITE: Dayton Electro.TDD: S05-9609-018 PAN: 6P1801SA PHOTO: 13
 DIRECTION: Northeast DATE: 10/11/96 PHOTOGRAPHER: Renninger
 DESCRIPTION: Overview of the vats in the plating line in Building 1.

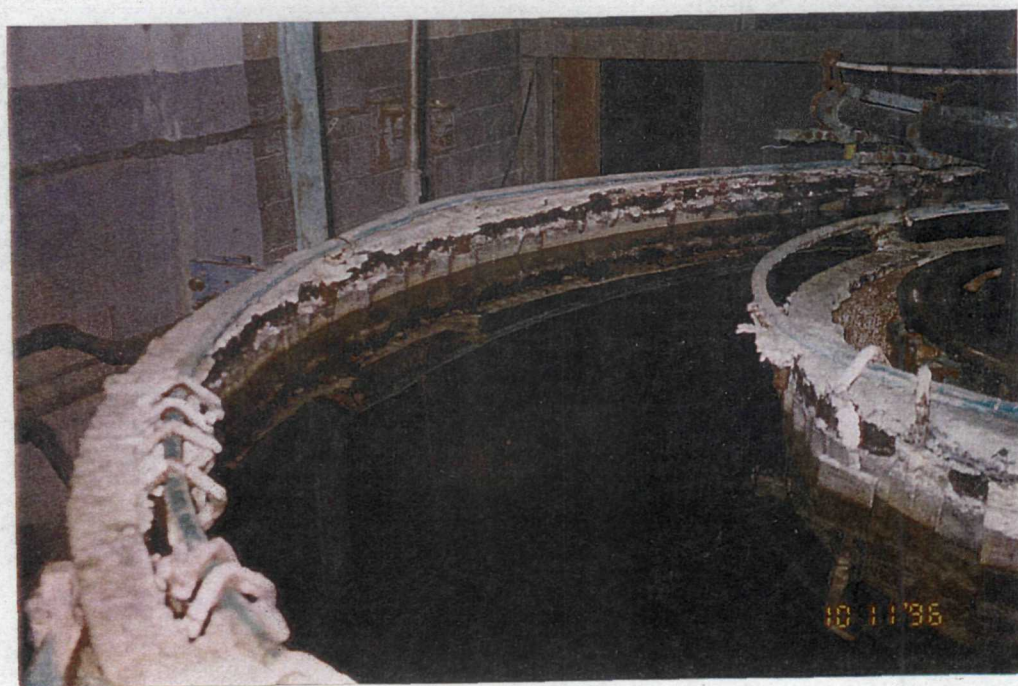
SITE: Dayton Electro.TDD: S05-9609-018 PAN: 6P1801SA PHOTO: 14
 DIRECTION: Northeast DATE: 10/11/96 PHOTOGRAPHER: Renninger
 DESCRIPTION: Contents of the horseshoe-shaped plating vat in Building 1.

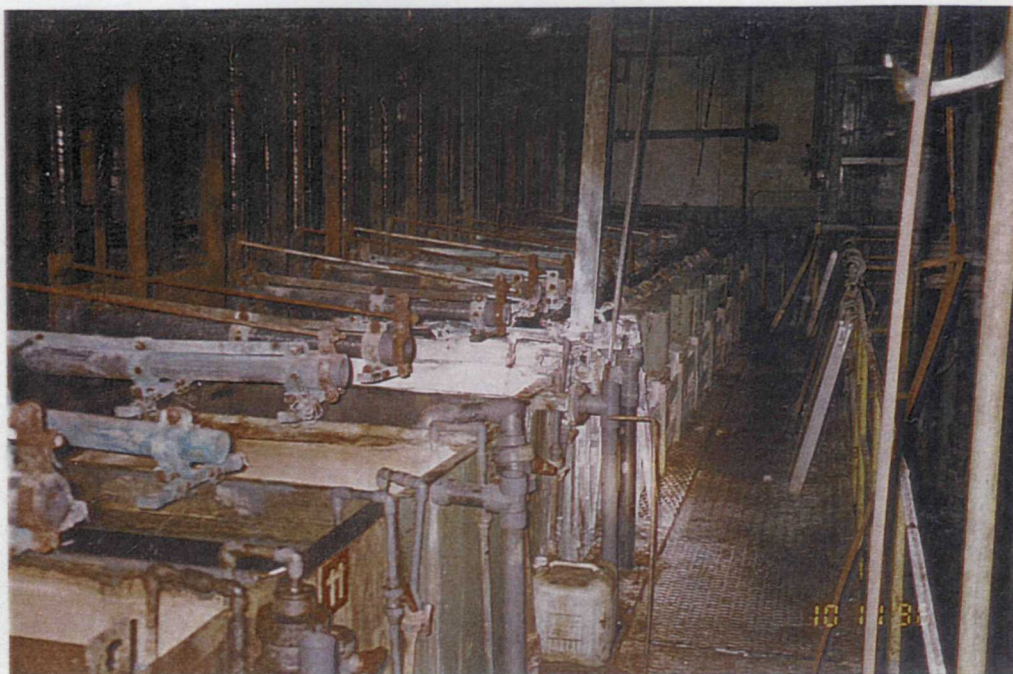
SITE: Dayton Electro.TDD: S05-9609-018 PAN: 6P1801SA PHOTO: 15
 DIRECTION: North DATE: 10/11/96 PHOTOGRAPHER: Renninger
 DESCRIPTION: Overview of the east side of the plating line in Building 1.

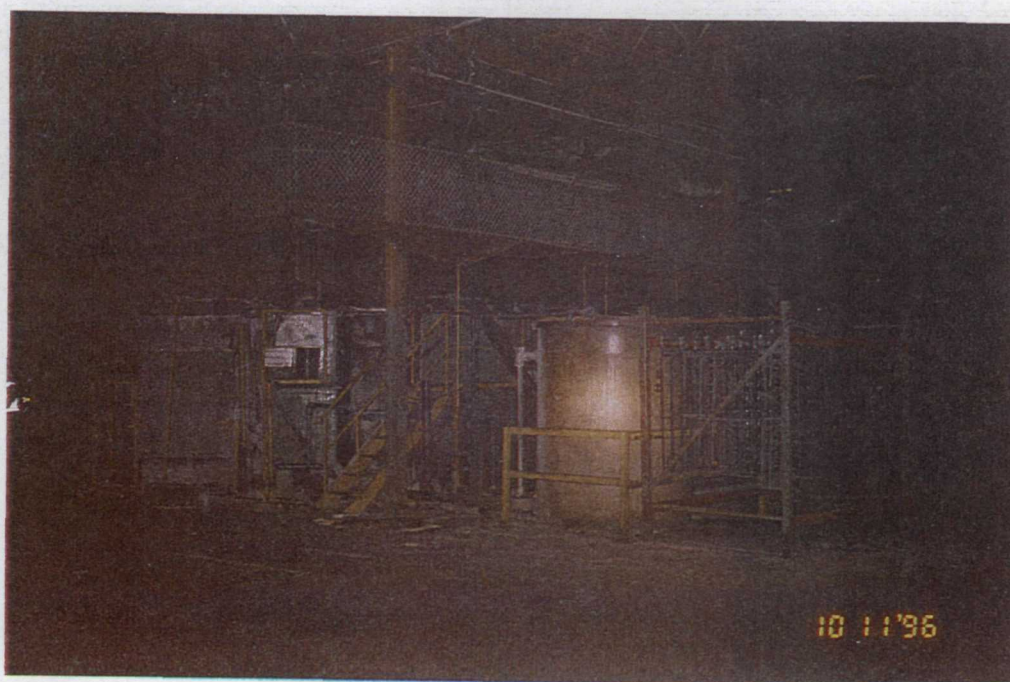
A total of 11 storage tanks were observed in Building 3. Tank capacities ranged from 1,000 to 10,000 gallons. All of the storage tanks were closed to the atmosphere and the interiors were unable to be accessed. Therefore, the tanks were all estimated to be 75% full. The contents of the tanks are unknown, but are assumed to be liquids. Eight 55-gallon drums and nine 5-gallon containers of unknown contents, were also observed in Building 3.

SITE: Dayton Electro.TDD: S05-9609-018 PAN: 6P1801SA PHOTO: 20
DIRECTION: Northeast DATE: 10/11/96 PHOTOGRAPHER: Renninger
DESCRIPTION: Overview of storage tanks and the plating line in Building 3.

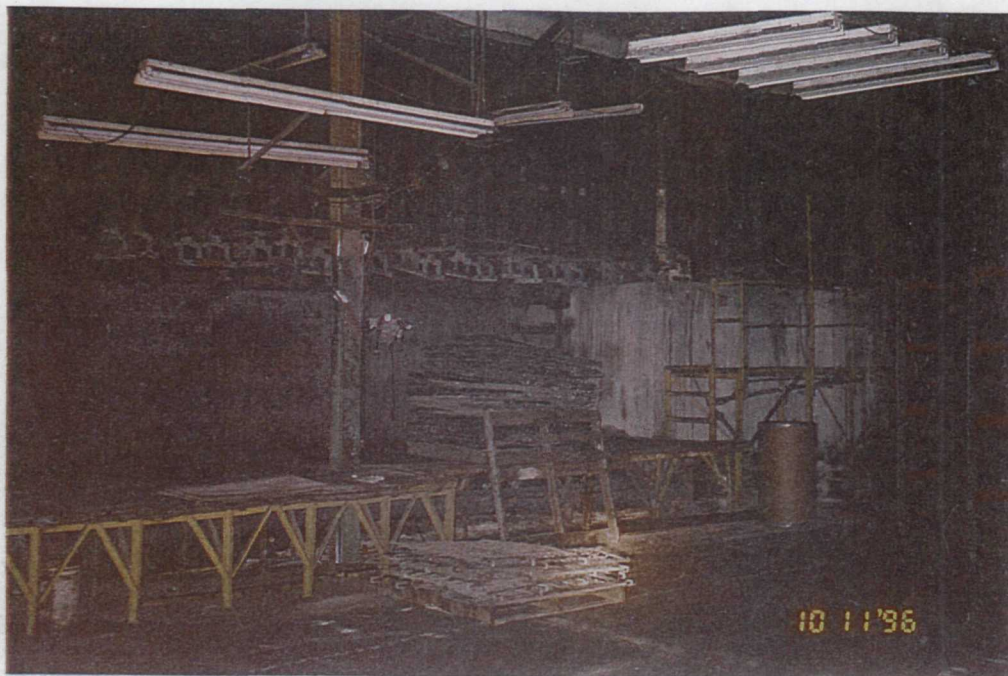
SITE: Dayton Electro.TDD: S05-9609-018 PAN: 6P1801SA PHOTO: 21
 DIRECTION: Southeast DATE: 10/11/96 PHOTOGRAPHER: Renninger
 DESCRIPTION: Overview of the plating line in Building 3.

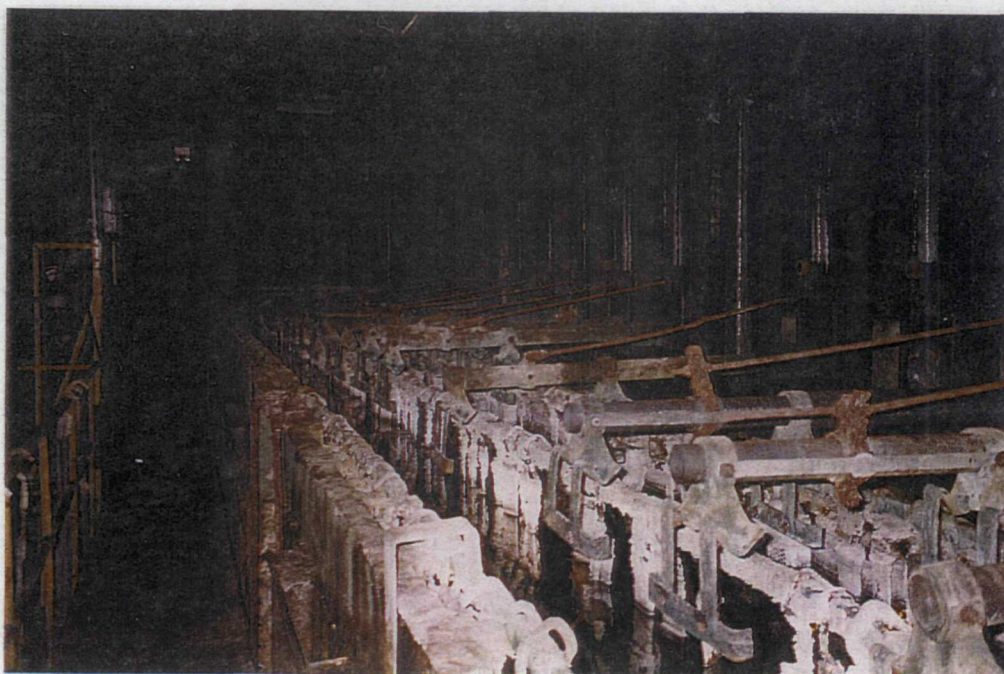
Plating Line 4 consists of 23 separate vats, ranging in capacity from 1,250 gallons to 19,000 gallons. Most of the vats were observed to be full or nearly full of liquids and sludges. However, a group of five of these vats, located at the southeast end of the plating line, were empty. The contents of a number of the vats were tested with pH paper and indicated pH values ranging from 1 to 14 S.U. The contents of the largest of the vats in Plating Line 4 was field-tested with an EM Quant cyanide test kit and was found to contain high levels of cyanide. This vat was located within 10 to 15 feet of vats containing low pH materials.

SITE: Dayton Electro.TDD: S05-9609-018 PAN: 6P1801SA PHOTO: 22
 DIRECTION: Northeast DATE: 10/11/96 PHOTOGRAPHER: Renninger
 DESCRIPTION: Overview of the vats in the plating line in Building 3.

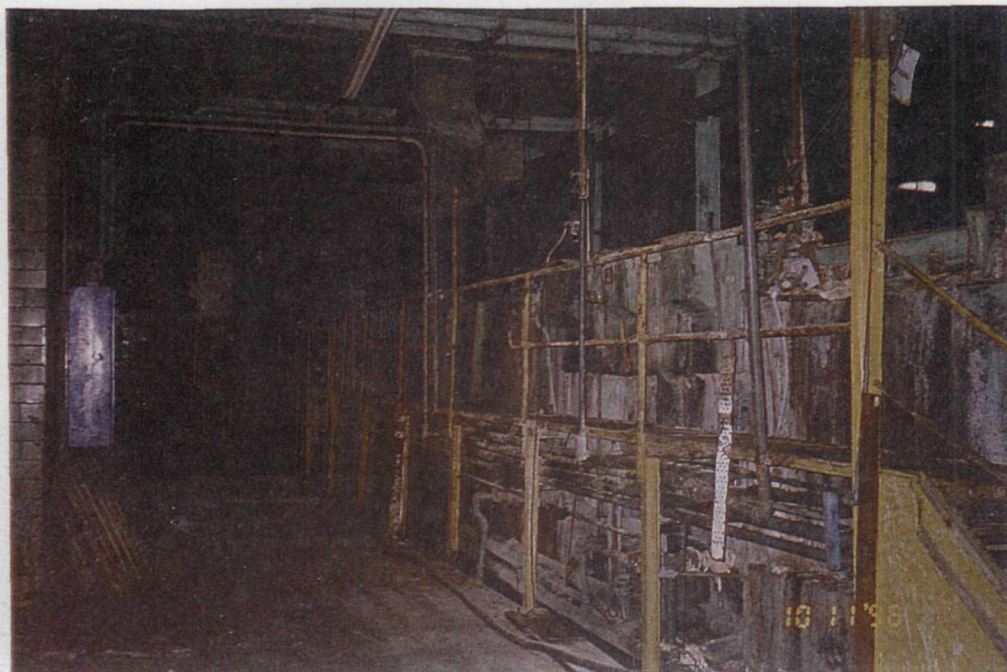
SITE: Dayton Electro.TDD: S05-9609-018 PAN: 6P1801SA PHOTO: 25
 DIRECTION: Northwest DATE: 10/11/96 PHOTOGRAPHER: Renninger,
 DESCRIPTION: Overview of the plating vats in Building 2.

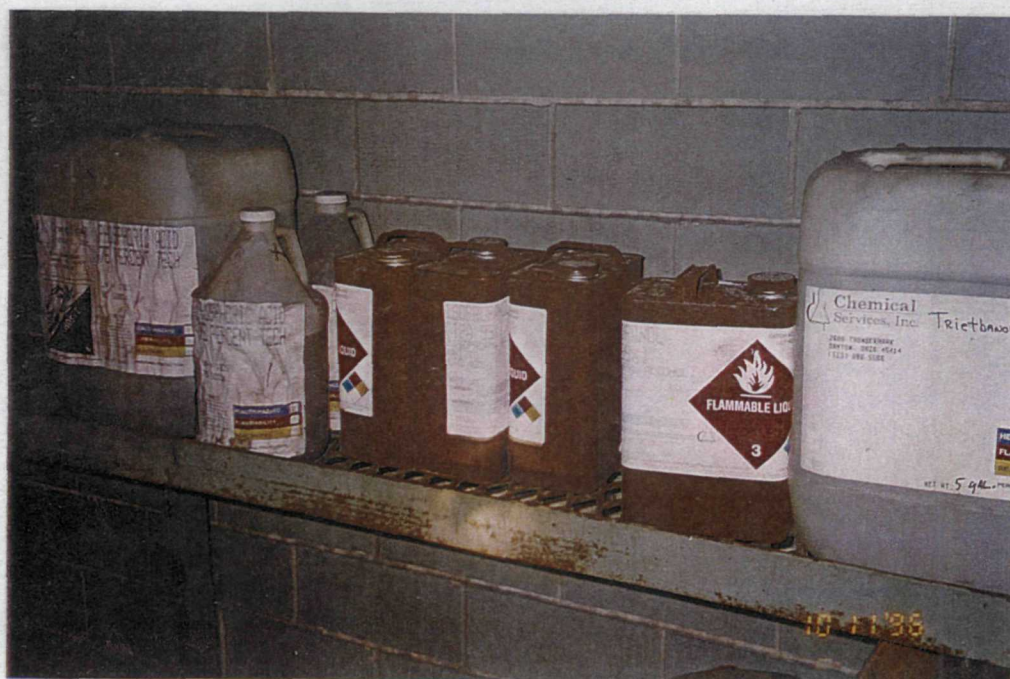
SITE: Dayton Electro.TDD: S05-9609-018 PAN: 6P1801SA PHOTO: 30
 DIRECTION: South DATE: 10/11/96 PHOTOGRAPHER: Renninger
 DESCRIPTION: Close-up of labels on small containers of various chemicals found in a storage area in Building 2.
